# Silverthorne Area

## Conditions Survey

Town of Silverthorne, Colorado

Surveyed and Submitted January and February 2013

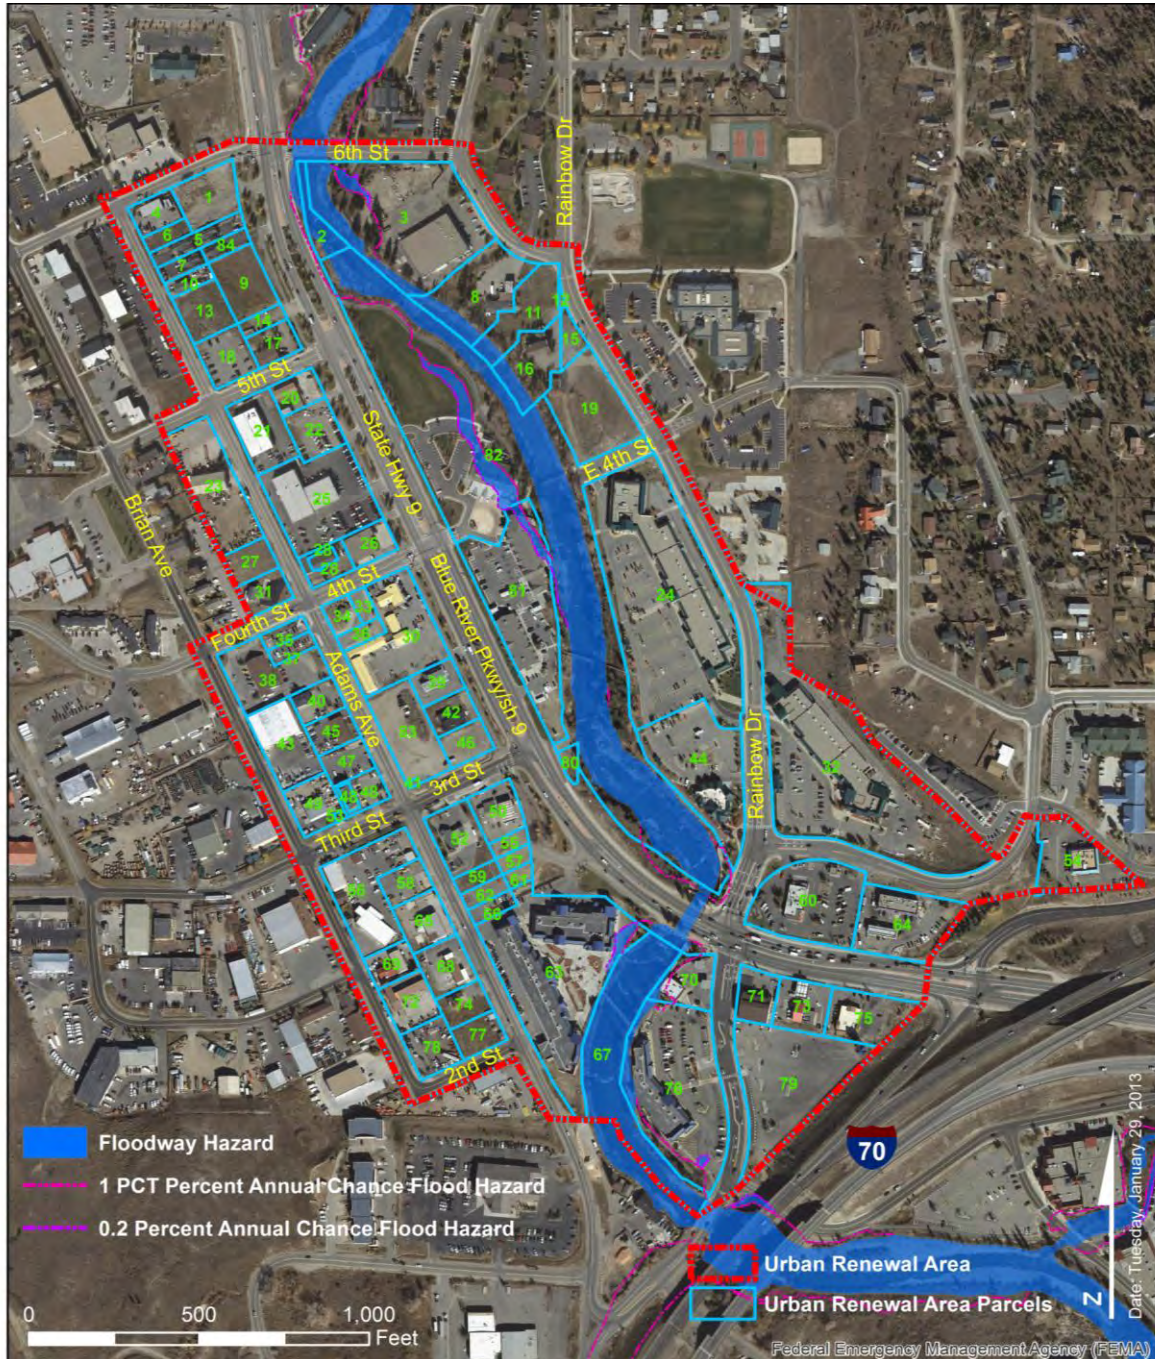
Figure 2: Flood Zone

Two additional factors considered to contribute to an unsafe environment are the presence of a flood zone and a high frequency of criminal incidents. As reflected in **Figure 2** below, there is a 100-year flood zone present and associated with the Blue River. It impacts properties within the Survey Area primarily east of Blue River Parkway and in the southwest quadrant of Blue River Parkway and Rainbow Drive. With regard to criminal activity, parcels located in the southeast quadrant of 4<sup>th</sup> Street and Adams Avenue report the most significant number of incidents – the Summit Stage Transfer Station (Parcels 33, 34, 36) and the 1<sup>st</sup> Interstate Inn (Parcel 30). Service calls to these properties are for assaults, harassment, drugs, intoxication, stolen property, domestic violence, theft, drugs, harassment, and run-aways.

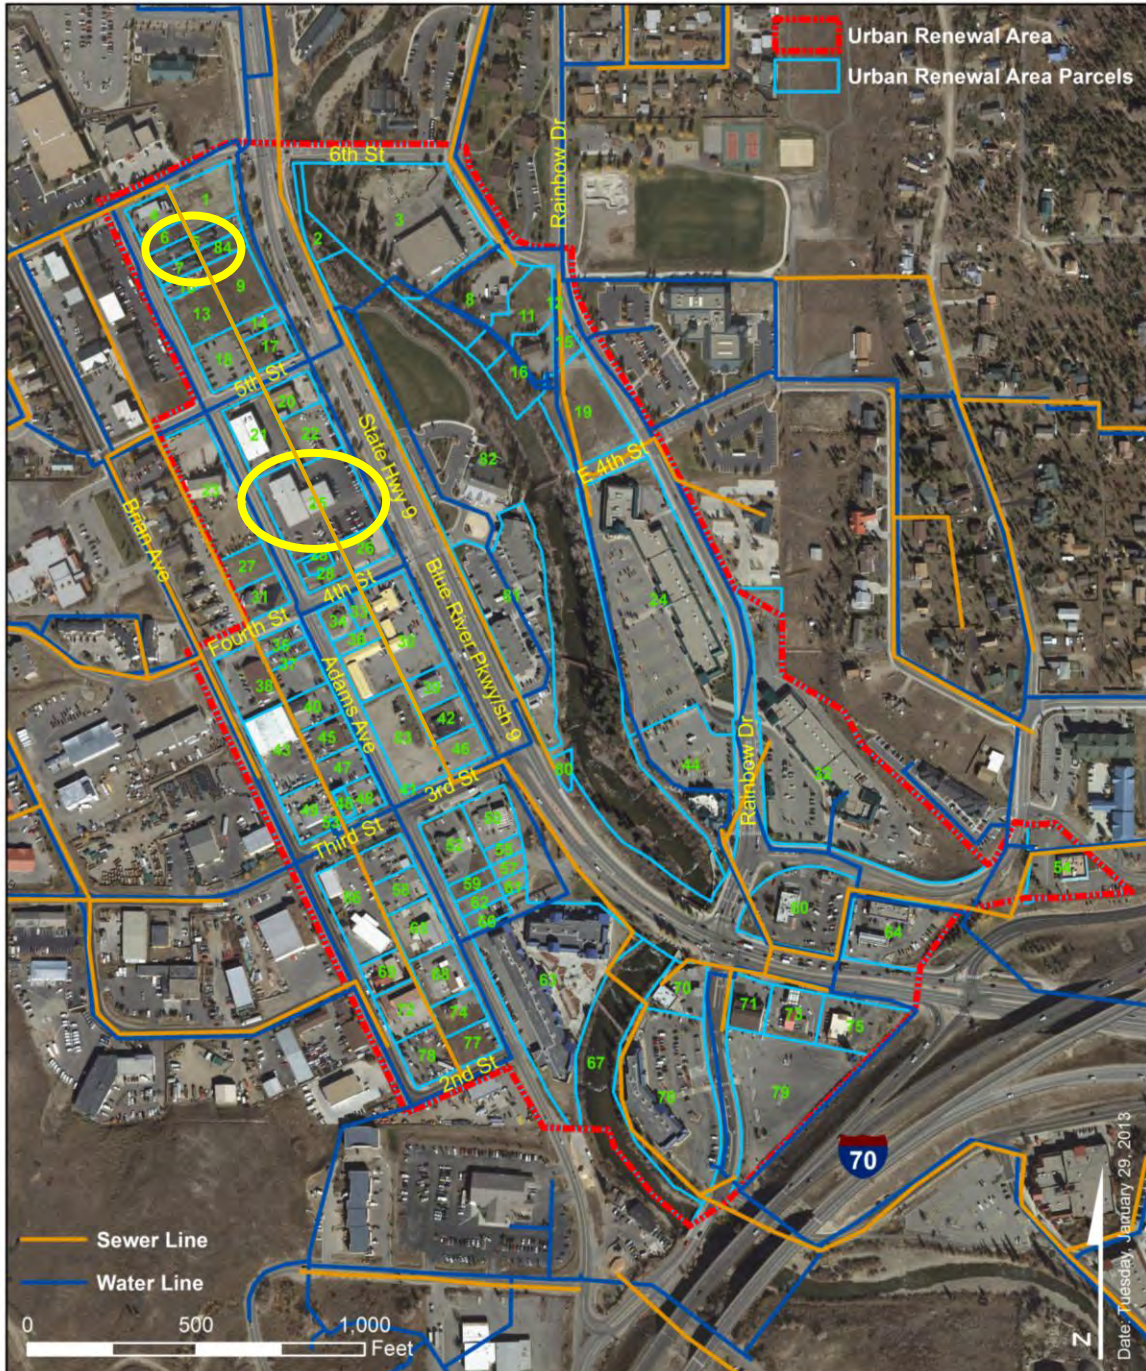
Figure 3: Water and Sewer Lines

Other public improvements that are either deteriorating or inadequate include those that provide water and sewer service to the Area. According to Town Staff, there are two pump stations and four wells within the Area. Whereas none can be easily moved, they will need to be considered in any redevelopment program for the Area. The pump house and well locations are part of the Town's water rights and therefore cannot be easily changed. Sewer lines run north down the mid-block between Highway 9 and Adams Avenue, and between Adams and Brian Avenues, along with other shallow utilities such as phone, electric, and cable. The sewer lines running mid-block between Highway 9 and Adams is a JSA line serving all of Wildercrest Road and Mesa Cortina, as well as adjacent Silverthorne businesses. Many of these sewer lines are clay pipe and even if not relocated, they will need to be upgraded or lined. The existing JSA line runs directly underneath Parcel 25 which is discussed in greater detail under (g) below. Water lines are undersized in certain locations such as within Adams Avenue between Buffalo Mountain Drive and 2<sup>nd</sup> Street. In addition, cast iron pipe water mains are present in several locations including on 6<sup>th</sup> Street west of Highway 9, which need to be replaced with ductile iron pipe.

Based on information provided by the Town of Silverthorne Public Works Department, improvements planned (and some funded) for the Area to address existing deficiencies include the reconstruction of the Blue River Parkway and Rainbow Drive intersection which will include widening Rainbow Drive and realigning it to better line up with Wildercrest Road. This is currently under final design by CDOT, with construction slated for 2014. In addition, CDOT is studying

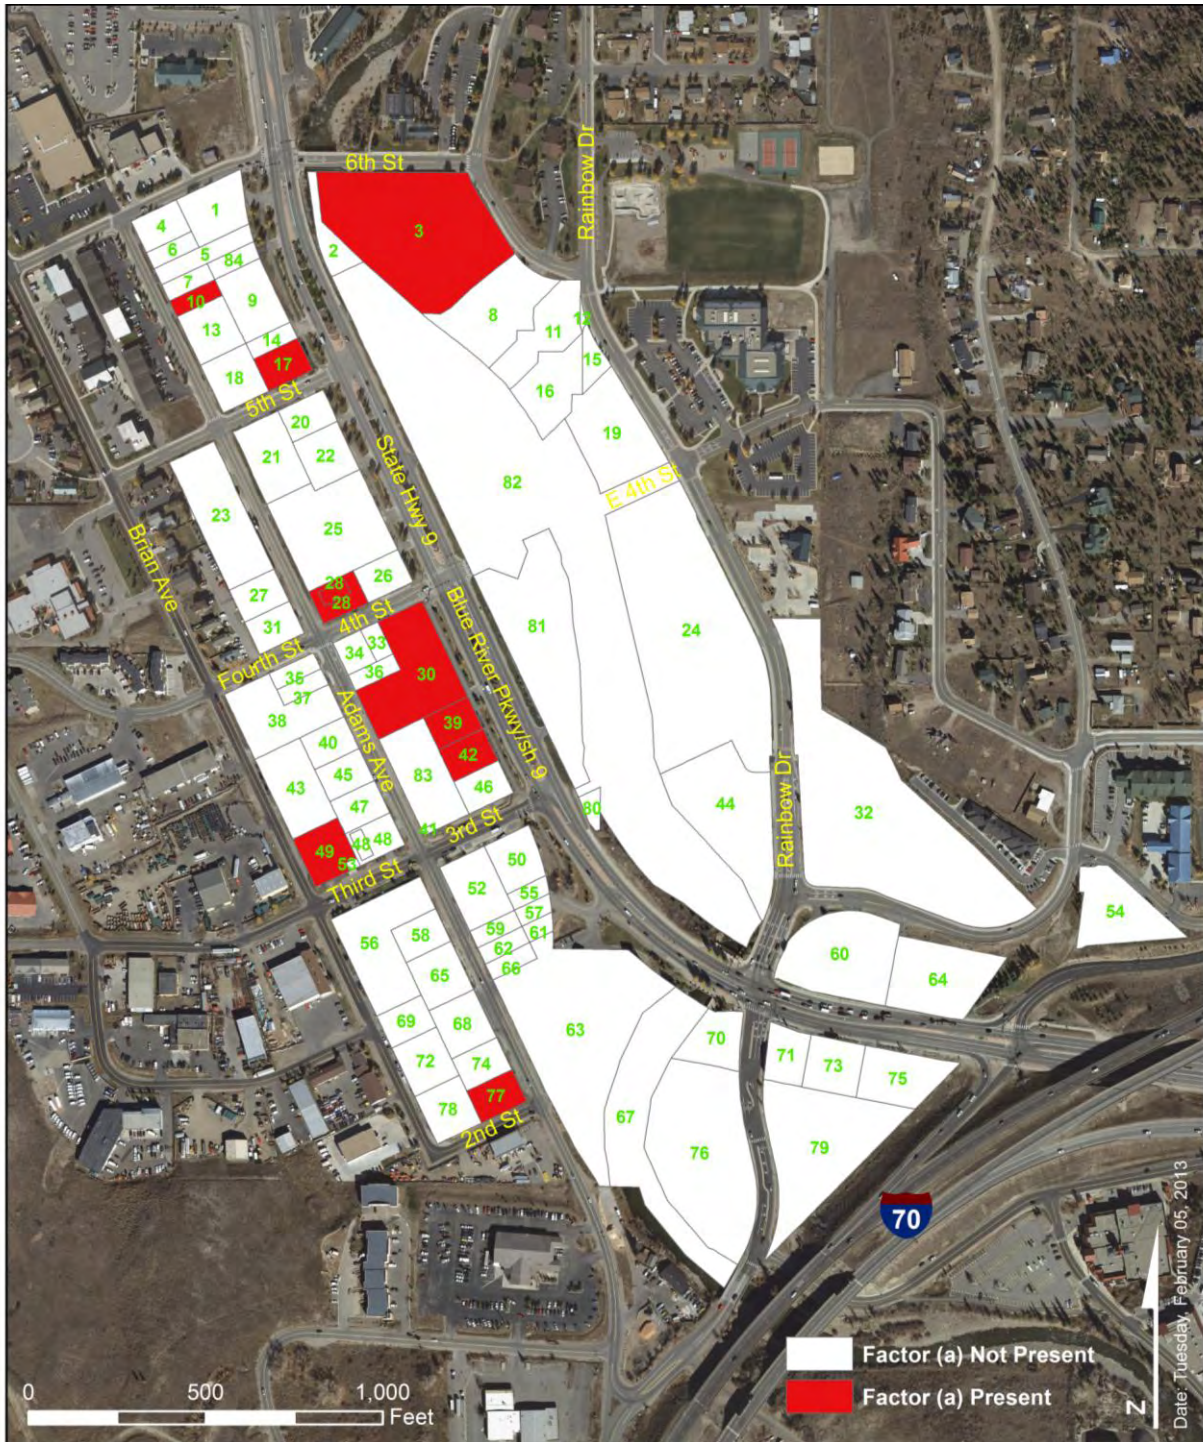
(a) Slum, deteriorated, or deteriorating structures

The Survey Area hosts a significant number of both commercial and industrial structures, some of which have met their useful life and others which have been neglected and show signs of disrepair. Whereas no interior inspections of buildings were conducted, deterioration is noted on the exterior of structures. Among the conditions which appear most prevalent are deteriorating exterior finishes, damaged fences and poorly maintained non-primary structures. Improvements which suffer from this factor are largely located in the northern portion of the Survey Area.

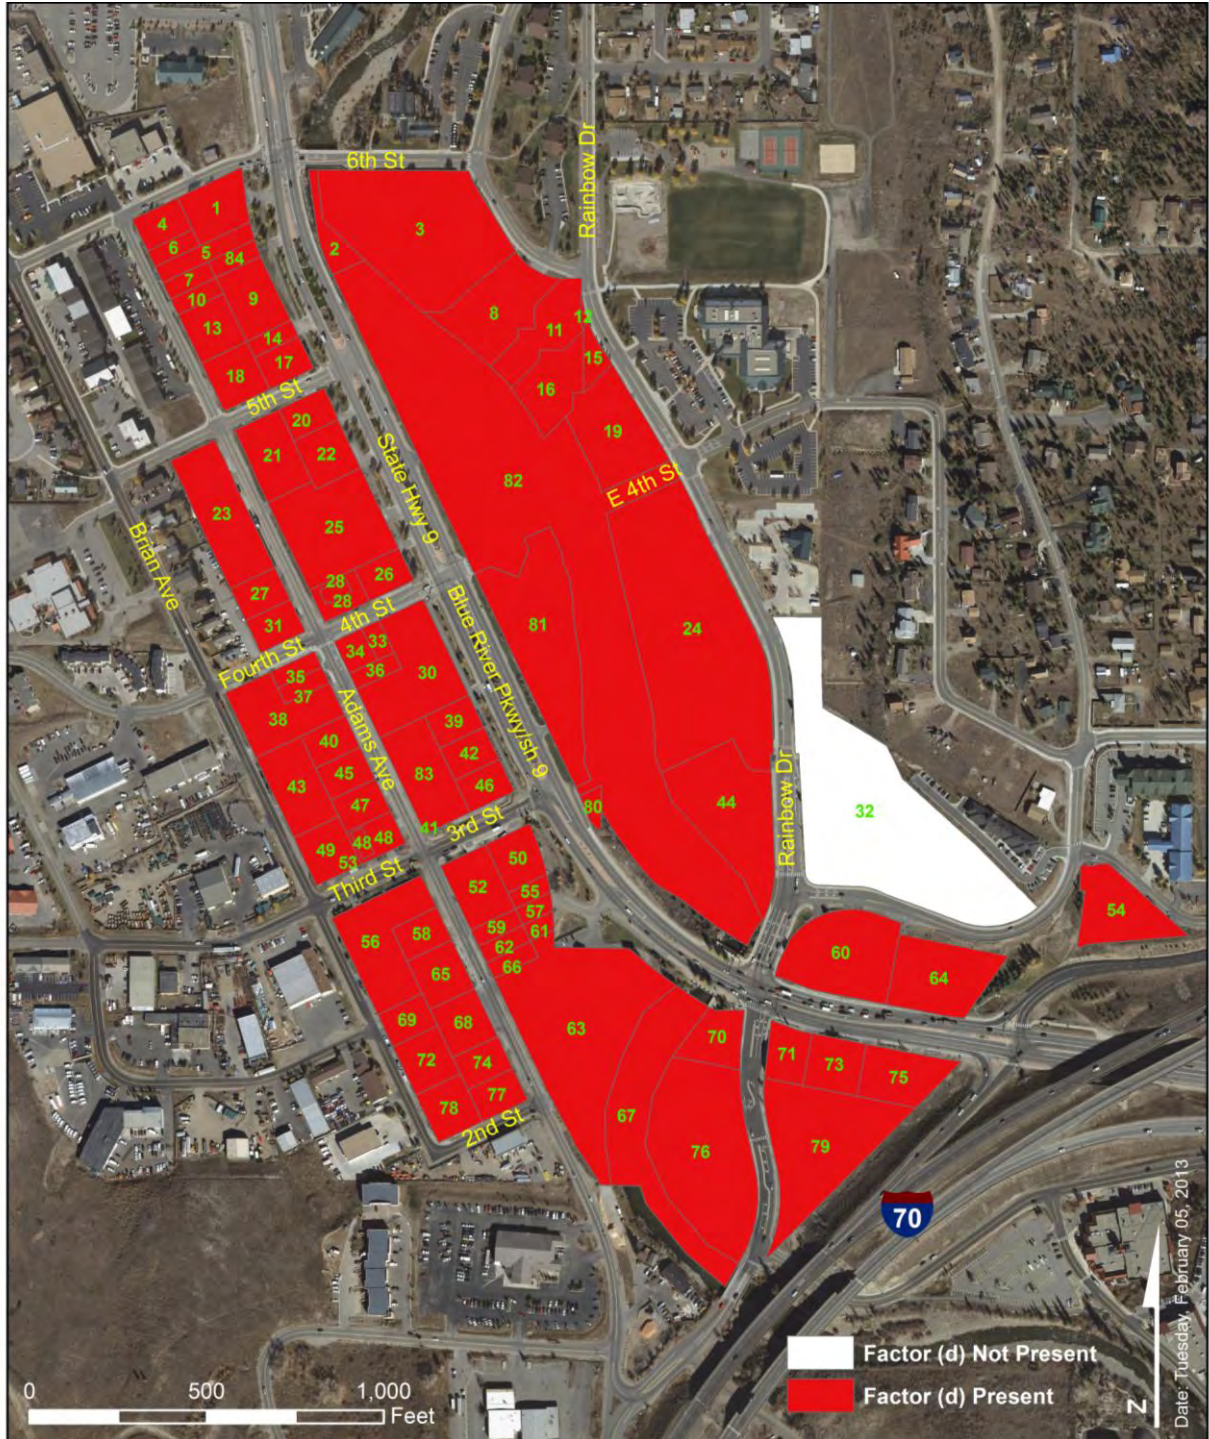
(d) Unsanitary or unsafe conditions

Multiple factors were identified that contribute to unsafe conditions in the Survey Area. While there are improvements that appear dilapidated, no information was provided that specifically characterized these structures as unsafe. Conditions which give rise to potentially dangerous circumstances are largely attributable to insufficient improvements for non-vehicular movement, including a lack of street

Other unsafe conditions include the presence of hazardous contaminants on at least two sites – Parcels 50 and 20. According to Town Staff, the Survey Area includes at least five current or former gas stations, many of which have had issues with contamination of groundwater, however documentation was only provided for these two. There is an active cleanup on Parcel 50 (3<sup>rd</sup> Street and Blue River Parkway) which is described in greater detail under (h) below and for which documentation is presented in Appendix D.

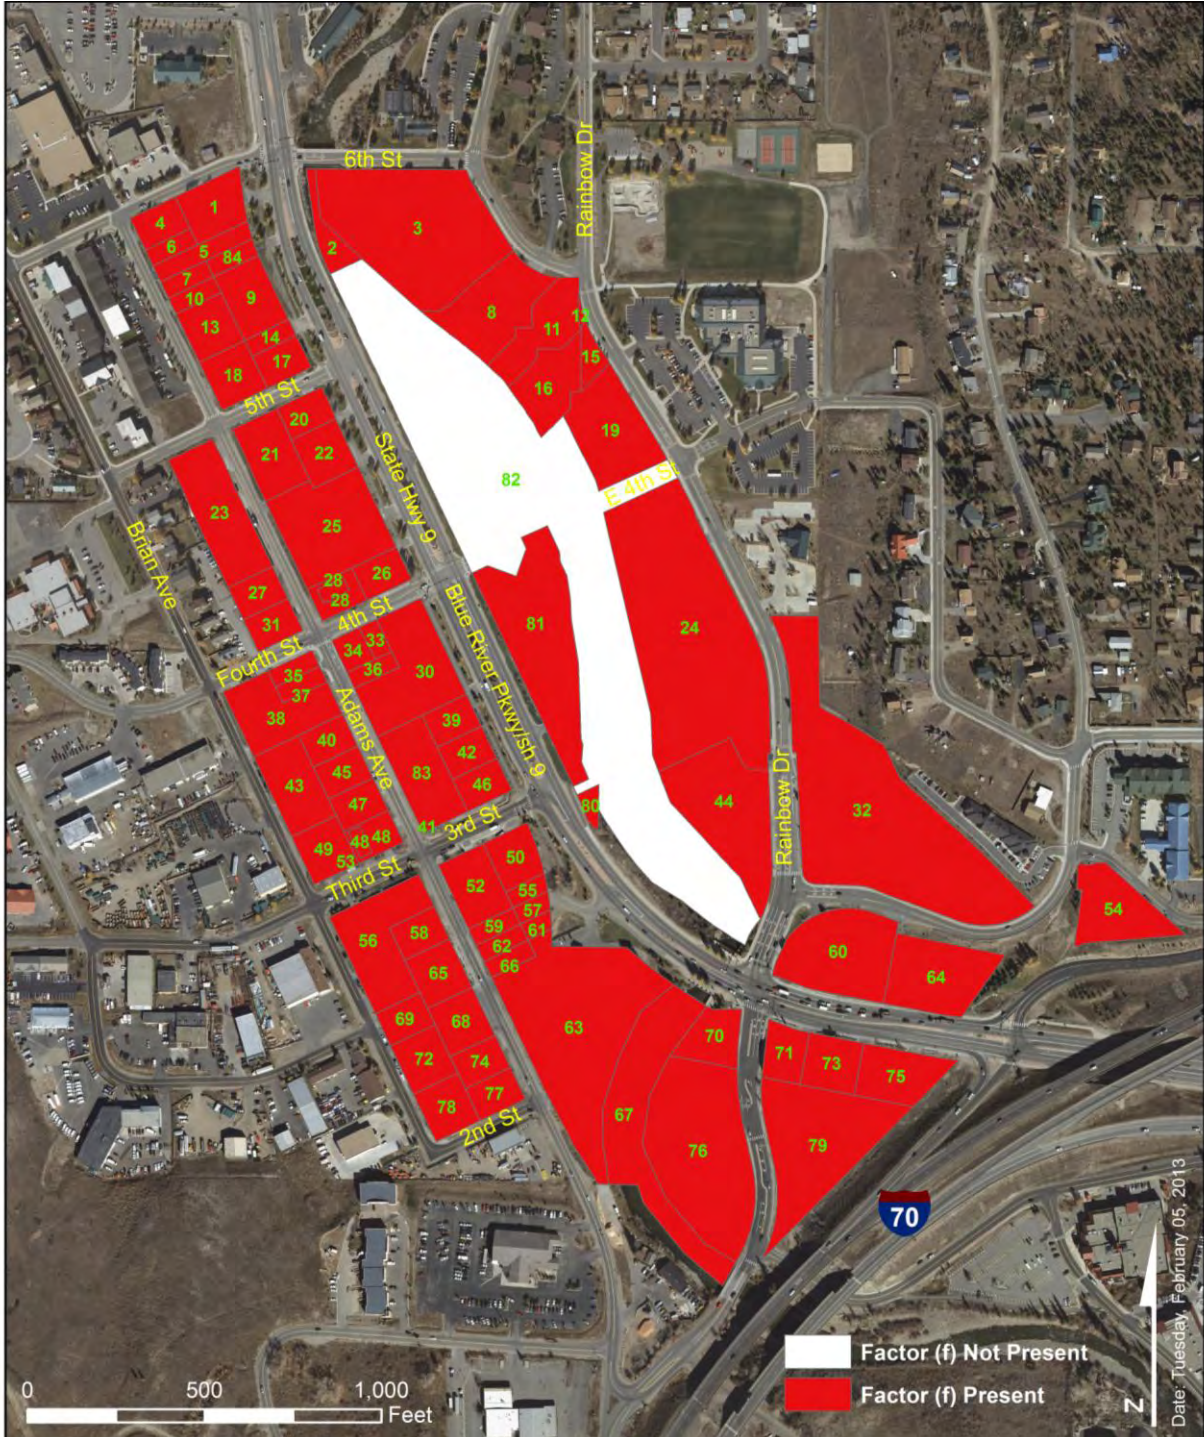
(f) Unusual topography or inadequate public improvements or utilities

With regard to topography, as explained under (d) above, parcels with steep slopes are primarily those located adjacent to the Blue River and closer to the I-70 corridor. An additional grade separation impedes development on Parcel 63. Inadequate public improvements in the Area, previously discussed, are largely associated with either an absence of streets or streets that are incomplete (lacking pavement, curbs and / or gutters, lighting, sidewalks and / or parking) and drainage. Among the sidewalks that are present, most are either too narrow for appropriate capacity or too close to the adjacent right-of-way, creating an unsafe environment for pedestrians. Drainage is provided via open roadside ditches and many either lack adequate culverts or are disjointed from each other.

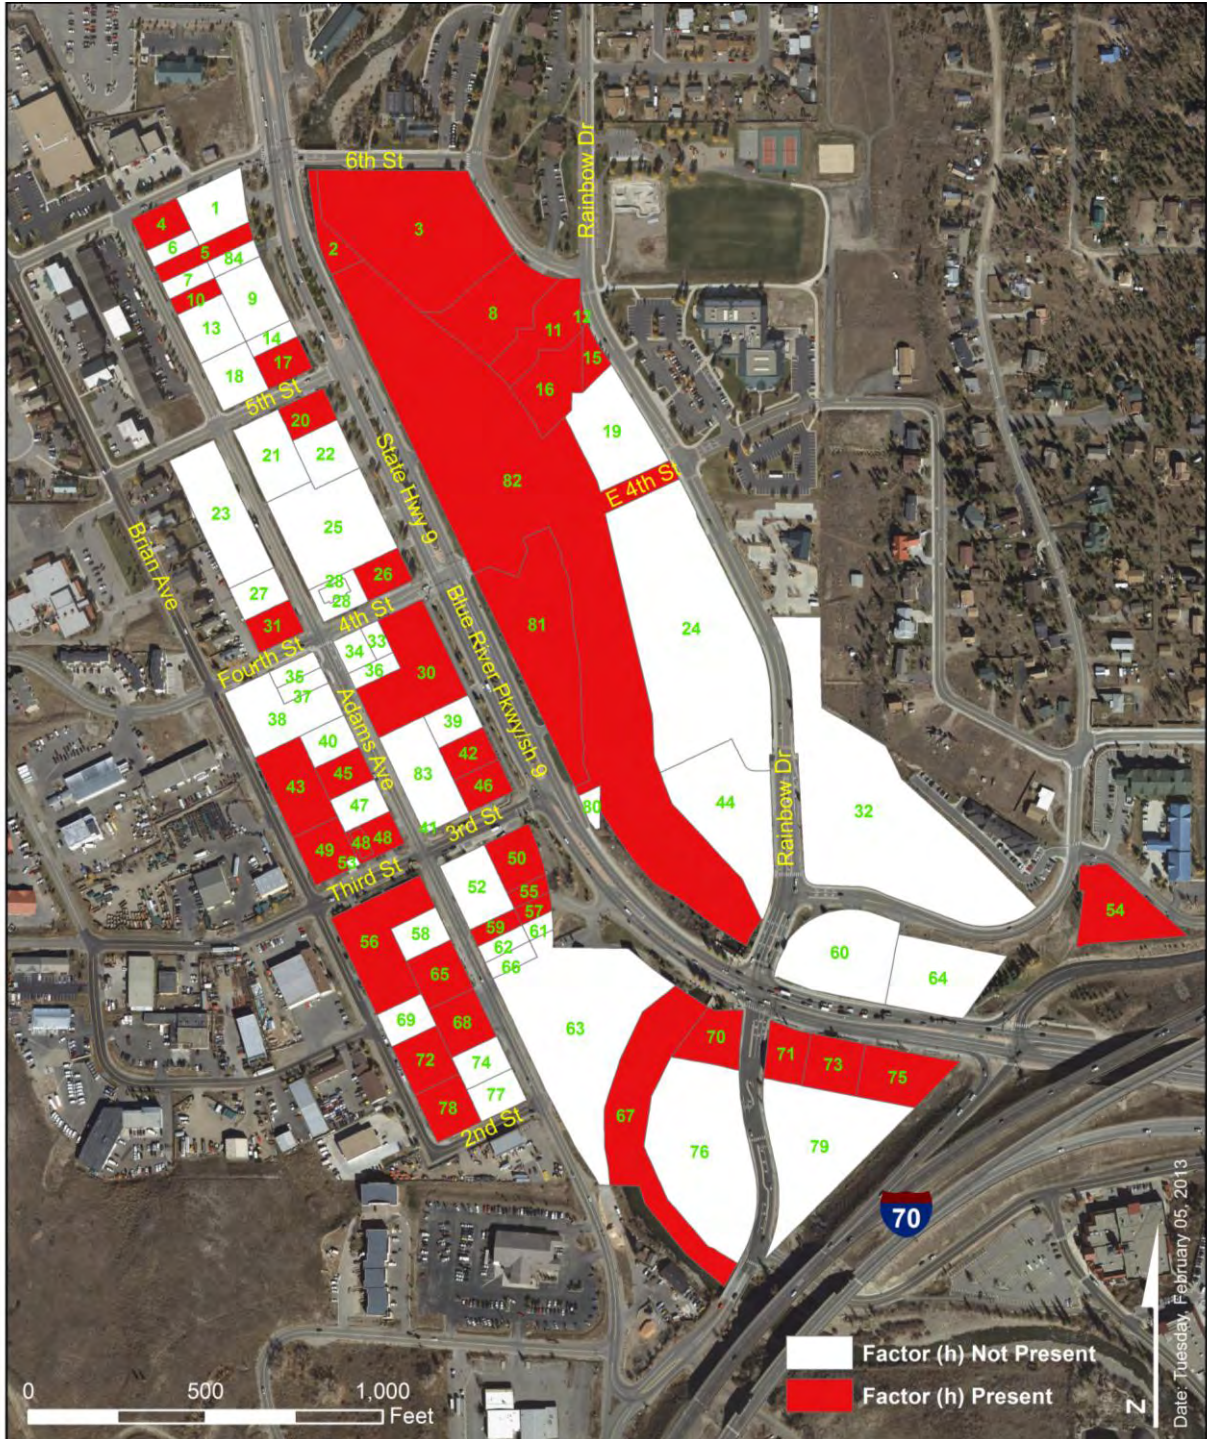
(h) The existence of conditions that endanger life or property by fire or other causes

Factors that threaten site users which were either observed or identified in the Survey Area include those previously mentioned – lack of protection from fire, presence of hazardous contaminants, high incidence of crime and the presence of a floodplain. Based on a report by representatives of the Lake Dillon Fire Protection District, there are numerous instances of buildings that do not have adequate fire protection infrastructure (sprinklers). With regard to hazardous contaminants, as explained earlier and in more detail under (j) below, there is the presence of hazardous contaminants as reported by the State of Colorado within the Survey Area. Detailed information about criminal activity was provided by the Town of Silverthorne Police Department and explained above. A 100-year flood zone is present within the Blue River corridor and impacts select properties located primarily east of Blue River Parkway.
